## CASE STUDY

# RENOLD HYDROSERVICE CHAIN

*12B1 Hydro Service  
Transmission chain*

### Transmission Chain Comparison: Renold Vs Competitor

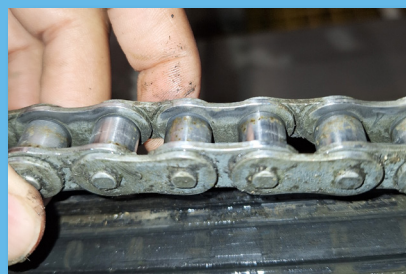
**Renold's HydroService chain is currently showing no signs of corrosion.**

*Renold HydroService chain*

Renold Hydroservice provides better corrosion protection compared to our competitor's chain. It offers 30x the corrosion protection of any conventional surface treatments and is hexavalent chrome free, which assists in providing a longer lasting product.

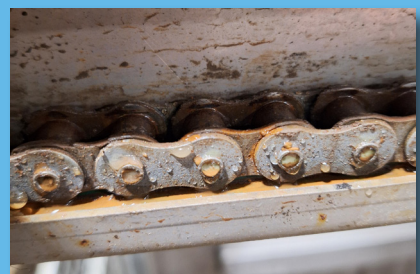
Our competitor's chain and Renold HydroService were both installed and commissioned in December 2024. Both have been in service for 3 months. Competitor's chain was found to have excessive wear and corrosion, resulting in elongation.

*Competitor chain*
